Detailed Slope Stability Analysis and Assessment of the Original Carsington Earth Embankment Dam Failure in the UK

Dr. Costas I. Sachpazis

ABSTRACT

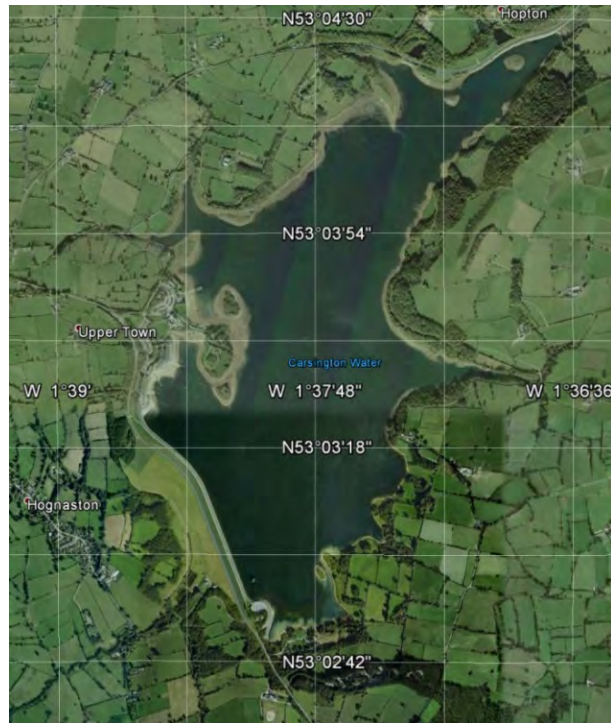
Figure 1: The study area of the Carsington Earth Embankment Dam in Derbyshire region, UK

The British Regional Water Authority in Derbyshire as part of its water storage system in order to regulate flows in the River Derwent, decided to construct a 35 m high and 1225 m long zone earth filled embankment from 1981 to 1984. The Carsington Dam (Fig. 1) would be one of the largest earth-fill dams in the UK. A 10 km long diversion tunnel would divert the water during the winter and been stored in the reservoir of an estimated capacity of 35 million m³. When the water level in the river was low, water would be released from the reservoir. The reservoir would also facilitate as a rainwater runoff regulatory hydraulic system (Fig. 2).

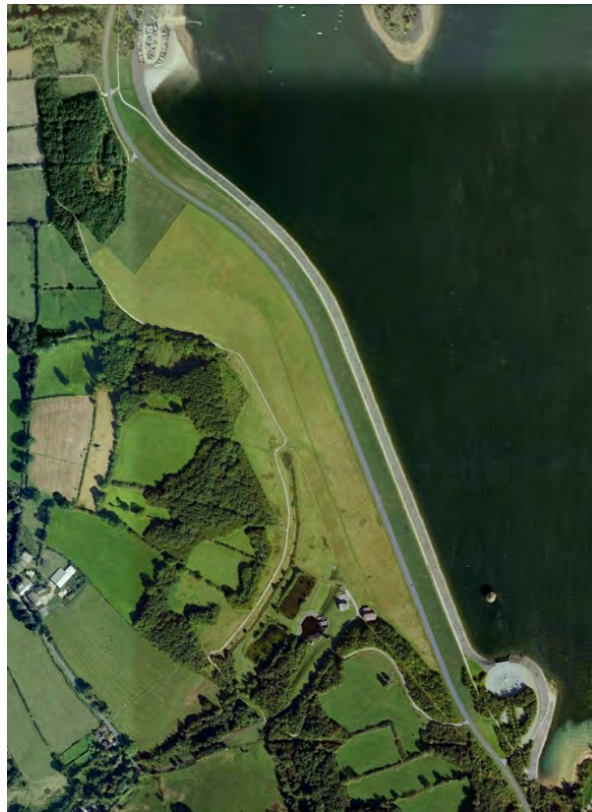
Figure 2: Close up of the reconstructed Carsington Earth Embankment Dam area.

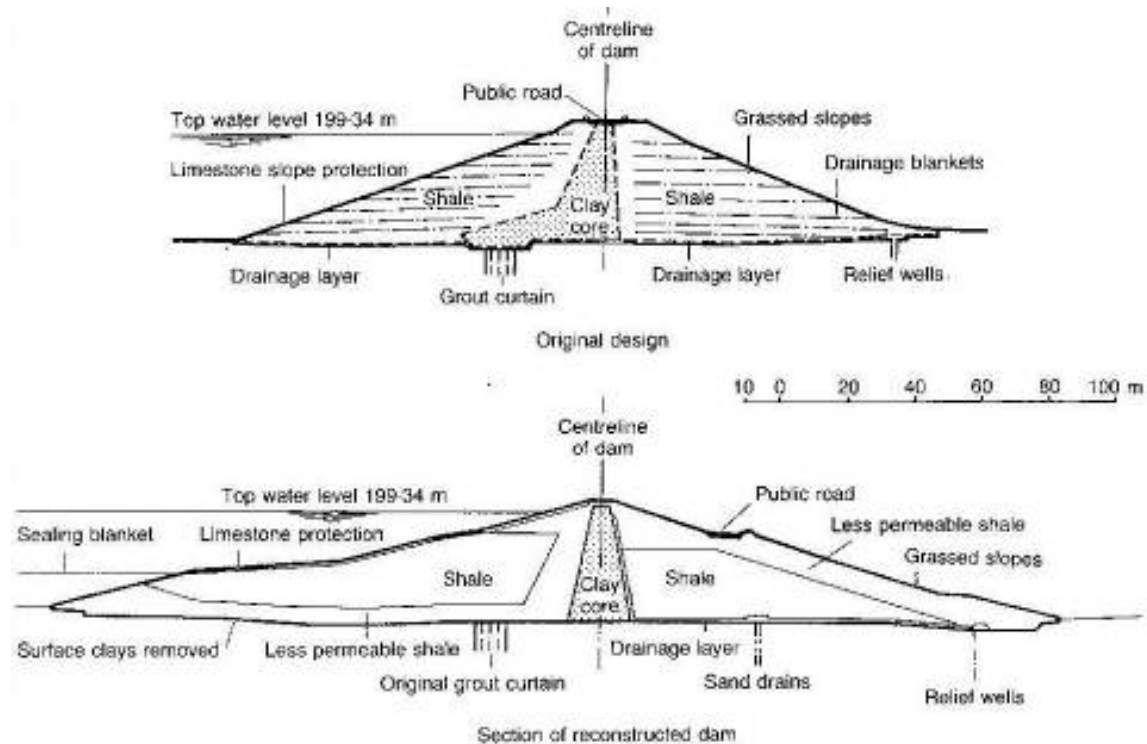
Figure 3: Representative cross sections of the original and reconstructed Carsington Earth Embankment Dam (Banyard et al., 1992).

The characteristics of the original construction of the Carsington Earth Embankment Dam, are briefly described as follows. A shallow trench that was excavated upstream of the centreline into the weathered gray foundation mudstone was connected to the central clayey core of the embankment. Below the base of the trench a cut-off grout curtain extended. In the downstream and upstream shells the earth fill was classified as Type A and Type B (Skempton and Vaughan, 1993). The Type A fill was described as a yellow brownish spotted clay with fine gravel < 5 mm and pebbles of mudstone and was placed immediately upstream and downstream of the clay core. The Type B soil was intended to be the same general type of material but without pebbles, and was located in the outer portions of the shells. The representative cross sections of the original and reconstructed Carsington Earth Embankment Dam are shown in Fig. 3 (Banyard et al., 1992).

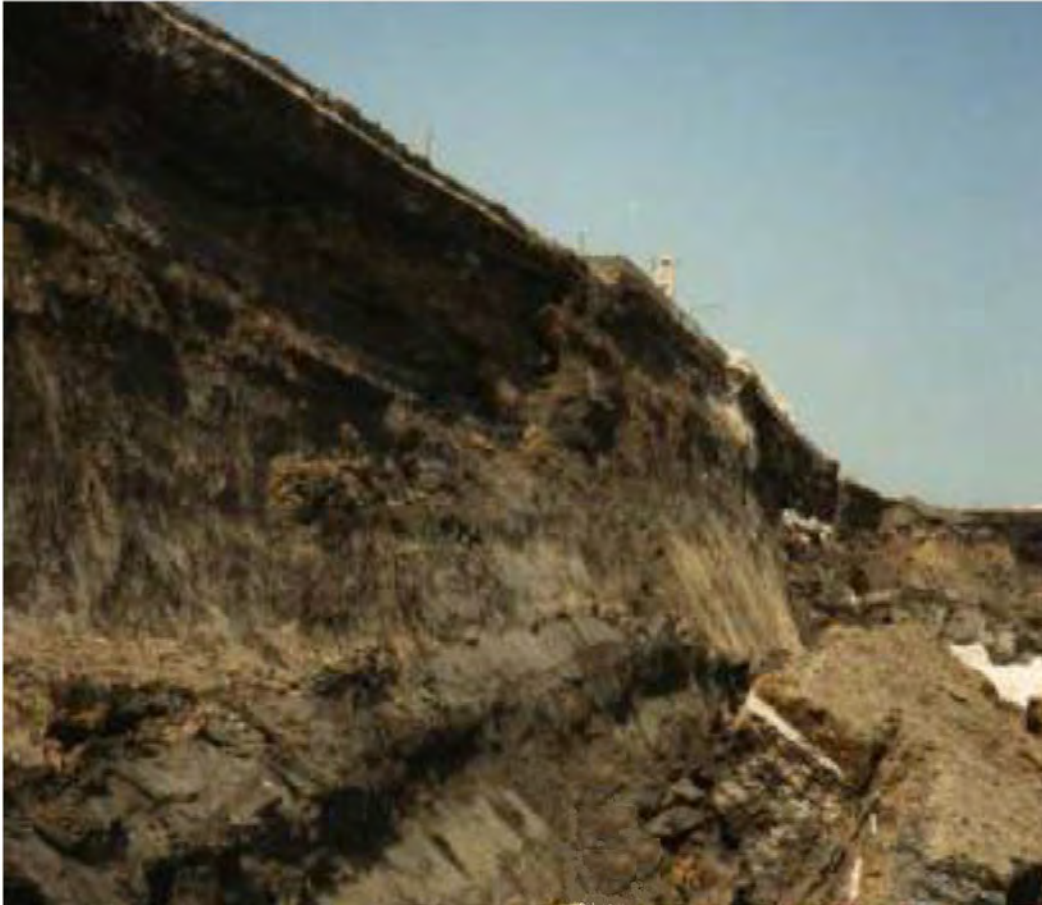
Figure (4). Close up of the upstream slip failure surface of the Carsington earth embankment dam, showing the slip propagated along the embankment with an embankment crest slumping of 11 m (Environment Agency, 2011).

According to Skempton and Coats, 1985 and Skempton and Vaughan, 1993, the exact incident description is as follows. The failure started in the early hours of 4 June 1984 with a 50 mm crack on the crest over a length of about 120 m. During the night of 5 June a major upstream slip occurred. The slip propagated along the embankment in both directions extending to a length of about 500 m, with an embankment crest slumping of 11 m, as shown in Fig. 4, and the upstream toe moving 13 m horizontally by 6 June 1984. The initial slip sheared through the core which already contained shear surfaces due to rutting and along a layer of yellow clay in the foundation

which contained solifluction shears. Both materials were brittle with low residual strengths (Skempton and Coats, 1985; Skempton and Vaughan, 1993).

According to Johnston et al., 1999, exact wording: “.....Investigations indicated that the initial slip resulted from shearing through the core and along a layer of yellow clay beneath the foundation. In addition, there were a number of shear surfaces in the core caused by rutting from construction plant. The yellow clay layer in the foundation was found to contain solifluction shears, and the factor of safety reduced to 1.0 when strength reductions due to pre-existing shear planes, progressive failure and lateral load transfer, were taken into account.....” (Johnston, 1995; Johnston et al., 1999).

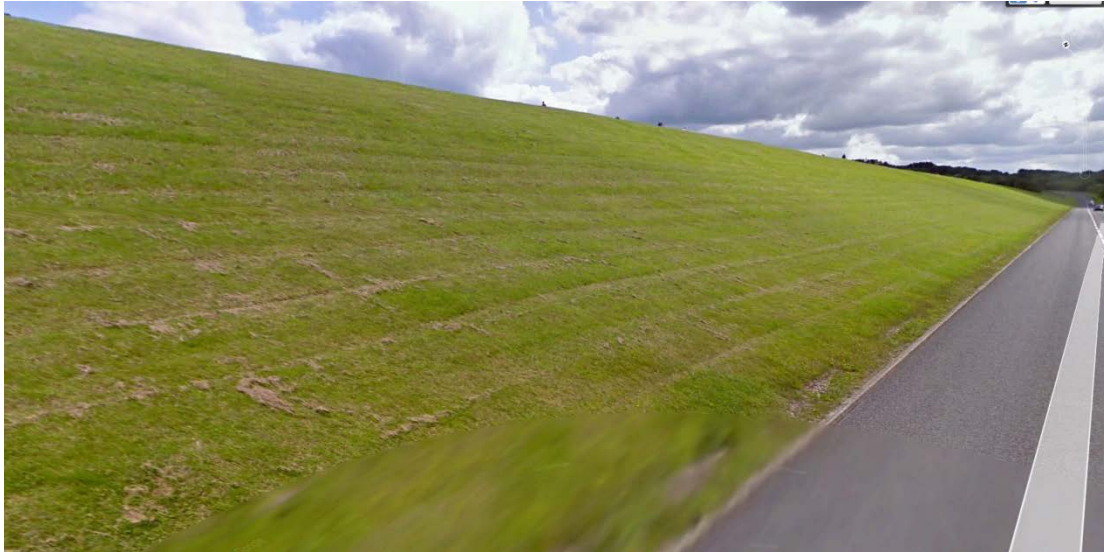
Figure (5).Downstream view of the reconstructed Earth Embankment of the Carsington Dam.

Remedial works and reconstruction of the failed dam is described by Banyard et al. (1992), Chalmers et al. (1993), Macdonald et al. (1993) and Vaughan et al. (1991). It commenced in February 1989 and was completed in 1991, seven years after the start of investigations. The main differences in cross-section are shown in Fig. 3. Reconstruction of the new dam involved excavation of two million cubic metres of the original dam to remove all failed material and lay a sound foundation. The downstream view of the reconstructed Earth Embankment of the Carsington Dam as stands nowadays is shown in Fig. 5.

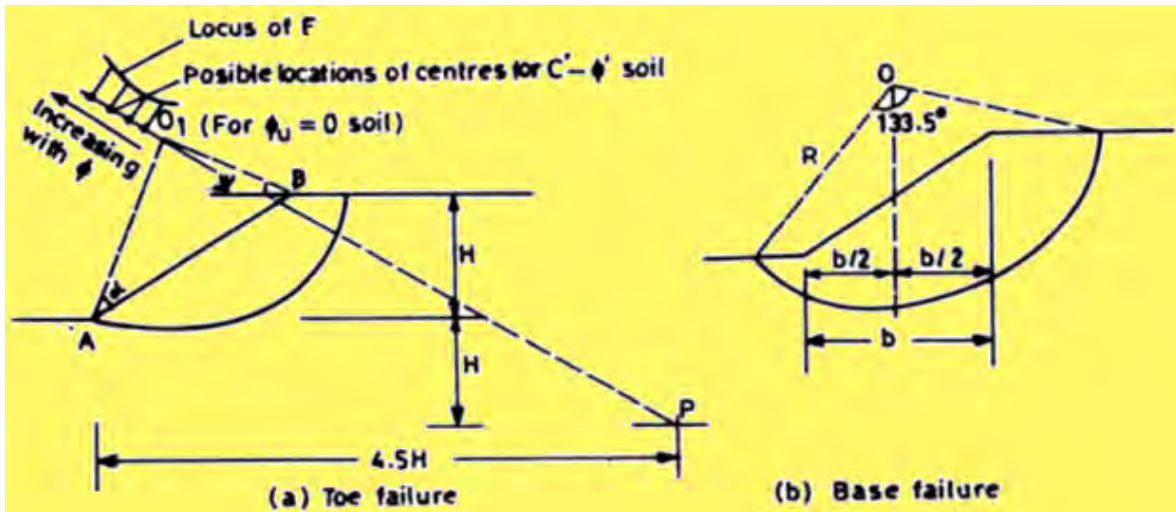
Figure 7: Location of critical circle (Ranjan, Rao, 2005).

Fellenius (1936) proposed an empirical procedure to find the centre of the most critical circle in a $\phi_u = 0$ soil. The centre O for the toe failure case can be located at the intersection of the two lines drawn from the ends A and B of the slope at angles α and ψ (Figure 7 (a)). The angles α and ψ vary with the slope β . Table 6 gives these values.

Jumikis (1962) further extended this method to the case of a homogeneous, $c' - \phi'$ soil. After obtaining the centre O_1 for a $\phi_u = 0$ soil, point P is located at a distance $4.5 H$ horizontally from the toe of the slope and H below the toe of the slope. The centre of the critical circle is then assumed to lie on the extension of line PO_1 and the factors of safety obtained are plotted to obtain a locus from which the minimum factor of safety can be read [Figure 7 (a)].

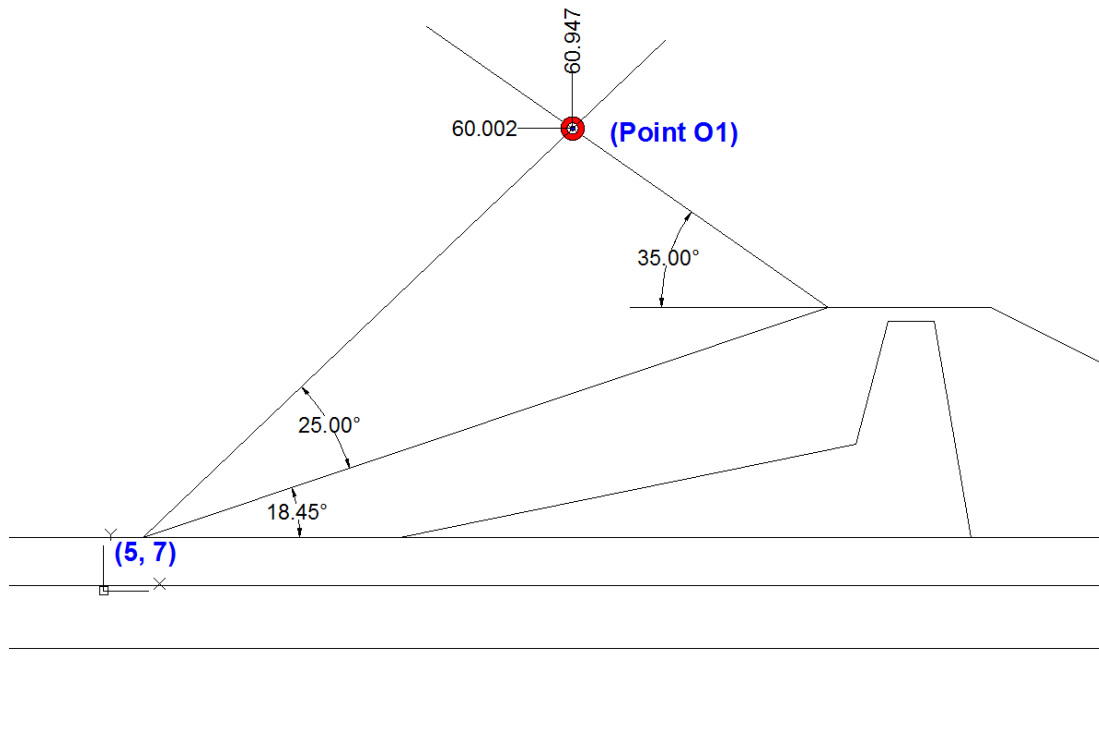
Figure 12: Coordinates (x, y) of the location of the most critical slip circle centre on the cross section of the Carsington Earth Embankment Dam, according to Fellenius method.

Therefore, the coordinates (x, y) of the location of the most critical slip circle centre point (O1) in the Carsington Earth Embankment Dam, as shown in Figure 12, are:

$$\begin{aligned} x &= 61 \\ y &= 60 \end{aligned}$$

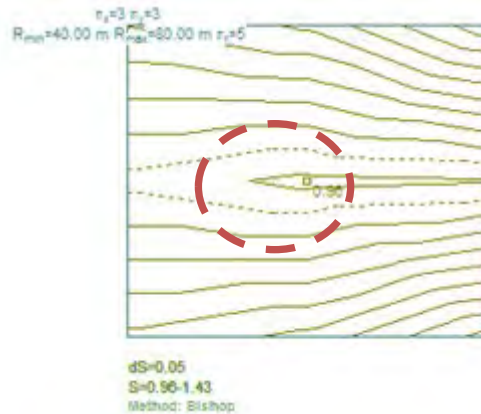
Figure 11b: Overall slope stability Factor of Safety for the loading case (a). Minimum FoS = 0.96, which means imminent failure conditions. (Bishop Method).

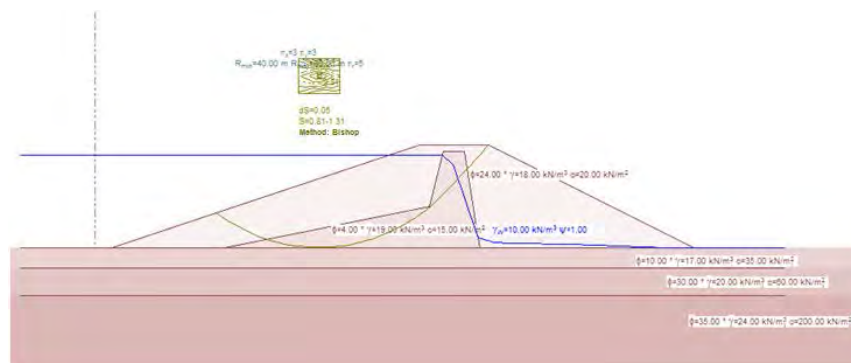
Figure 13a: Overall slope stability Factor of Safety for the loading case (b). Minimum FoS = 0.81, which means failure conditions. (Bishop Method)

The overall minimum stability factor of safety for the loading case (b), i.e. when the reservoir is full of water and some steady state seepage into the Carsington Earth Embankment Dam is established, was calculated equal to **0.81**, which means failure conditions. The computed analysis results are illustrated in the following Figures (Fig. 13a and Fig. 13b).

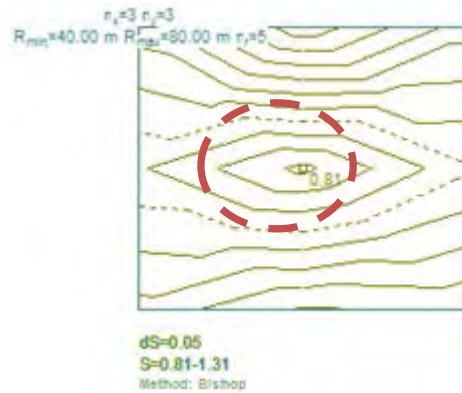
Figure 13b: Overall slope stability Factor of Safety for the loading case (b). Minimum FoS = 0.81, which means failure conditions. (Bishop Method).
